DOT/FAA/AR-02/80

Impact Damage Characterization and Damage Tolerance of Composite Sandwich Airframe Structures – Phase II

October 2002

Final Report

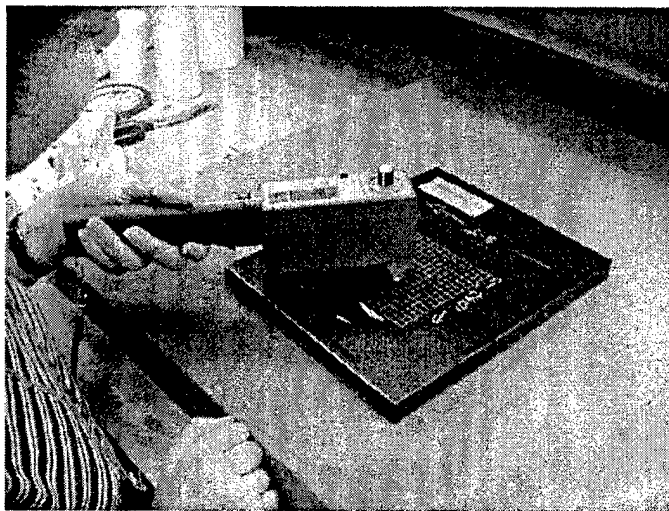
FIGURE 5. MITSUI WOODPECKER AUTOMATED TAP TESTER

In mechanical tap testing, the impact (tap) force is measured using an accelerometer that is mounted behind the impactor. The magnitude of the force and impact duration will depend on the constitutive properties of the sandwich components, impact energy, and impactor properties. The duration of impact (period) has been reported to be rather insensitive to the magnitude of the peak impact force for sandwich panels [5], which ensures repeatability. However, the impact duration will be significantly altered when the local stiffness of the sandwich structure is reduced due to the presence of damage. This change in impact duration is used to identify damage in sandwich structures. In the present investigation, the Mitsui Woodpecker Automated Tap Tester [6] (shown in figure 5) was used to identify the impact damage in sandwich panels.

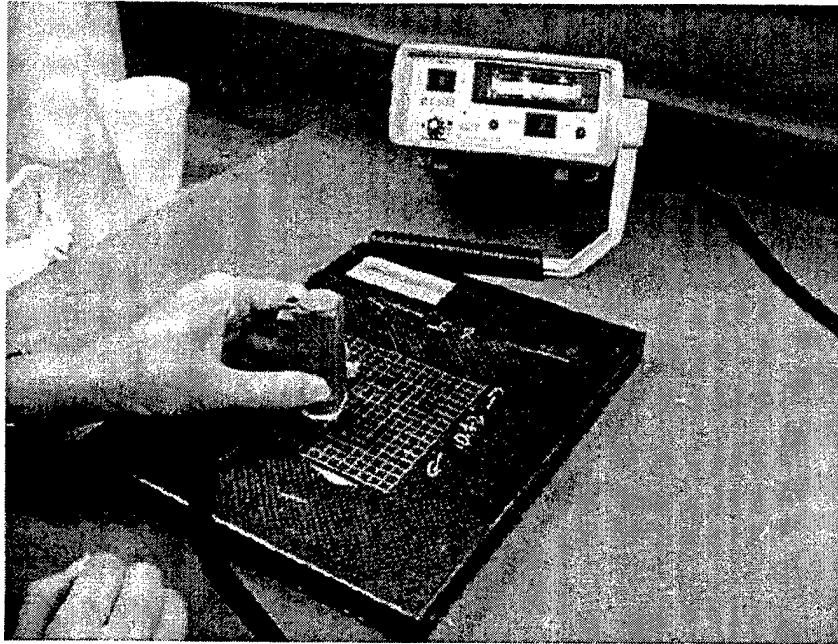
FIGURE 7. V-95 BOND TESTER USED FOR MECHANICAL IMPEDANCE ANALYSIS

In the MIA method [7], the stiffness of the structure in contact with a probe tip is measured. The mechanical impedance (stiffness) of the structure is a function of the constitutive properties of the sandwich components. The MIA method has been frequently used for identifying flaws in adhesive bonds. The presence of facesheet or core damage will reduce the mechanical impedance of the sandwich structure, and can result in a phase or amplitude change to the displayed signal, depending on the frequency of the probe. The probe consists of two piezoelectric crystals with the driver positioned behind the receiver within the same holder. The driver converts electrical energy into sonic vibrations and the receiver, in direct contact with the test surface, converts the modified vibrations into electrical signals for processing by the instrument. The V-95 Low-frequency bond tester used in the present study is illustrated in figure 7.
